**ALLSTAR PZL GLIDER Ltd.**  
ul. Cieszyńska 325  
43-300 Bielsko-Biała  
phone: +48 (0)33 8125021, fax: +48 (0)33 8123739  
e-mail: office@szd.com.pl  
Approval no : EASA AP 108

**SERVICE BULLETIN**  
**No BE-010/SZD-59/2009 „ACRO”**

**CONCERNS:** Inspection of the fuselage frame joints.

**SERVICE BULLETIN**  
**No BE-011/SZD-59/2009 „ACRO”**

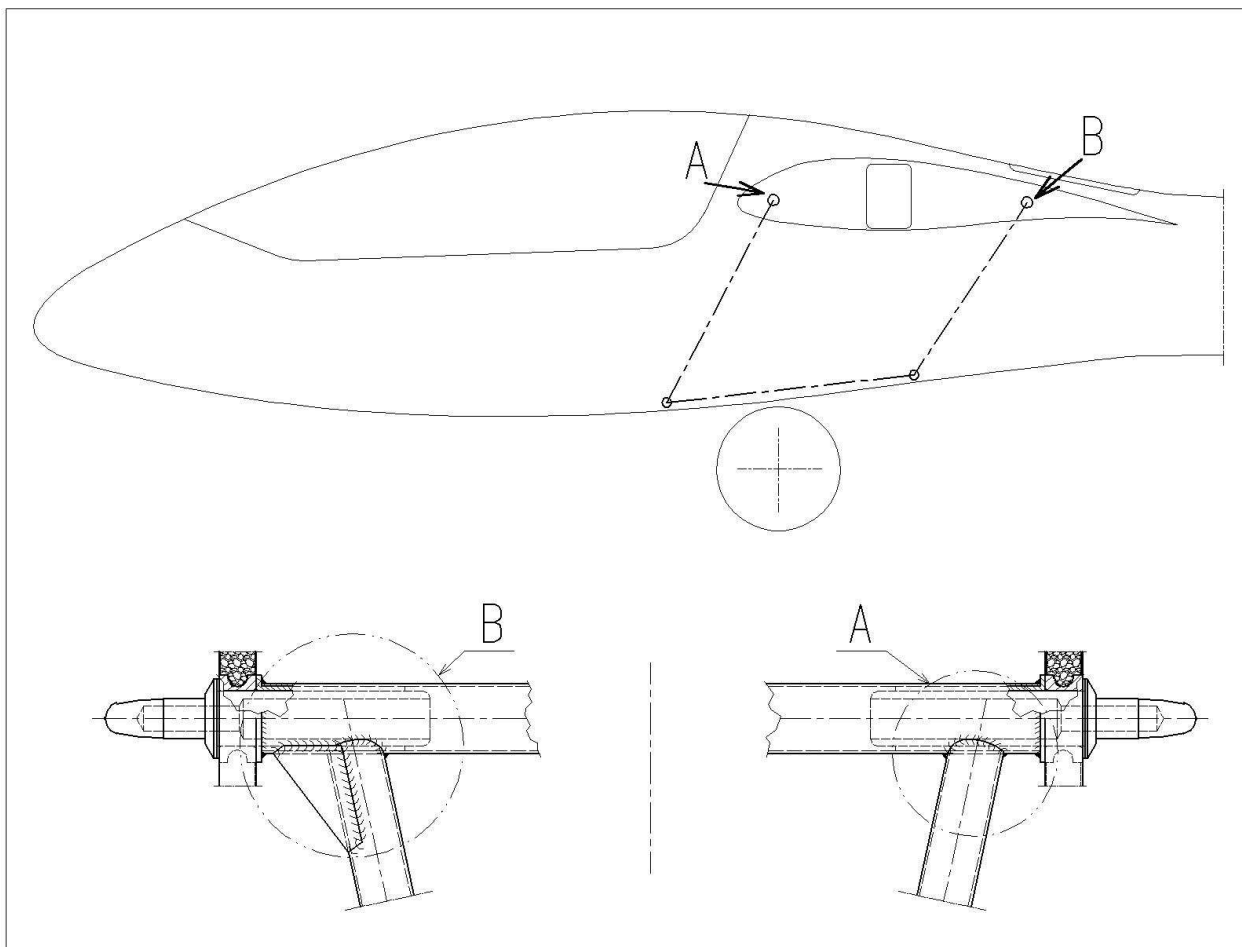
In 4 SZD-59 gliders a cracks of the fuselage frame tube has been detected, at the front wing fixing point, near welded joint.

By the cockpit's cutout the front frame tube at welded joints, next to the front wing fixing pivots (see Fig.1, A )is to be inspected by visual methods. All circumference of the tube is to be inspected. By the sighthole between wings, rear frame tube is to be inspected, at the welded joints (see Fig.1, B). All circumference of the tube is to be inspected. For rear tube inspection, tools like a digital camera, endoscope or similar can be necessary. In a case of a crack is found, the glider is to be found non-airworthy until a repair is done, and the operator of a glider is requested to report the case to the manufacturer. Please enclose following information: serial number of the glider, total flight time and total amount of landings.

Fig.1. Cracks location.

5.1. The inspection of the front tube is to be repeated before every day of flying. The inspection of the rear tube is to be repeated after each 5 flying days.

5.2. The repair method will be given by a separate bulletin.

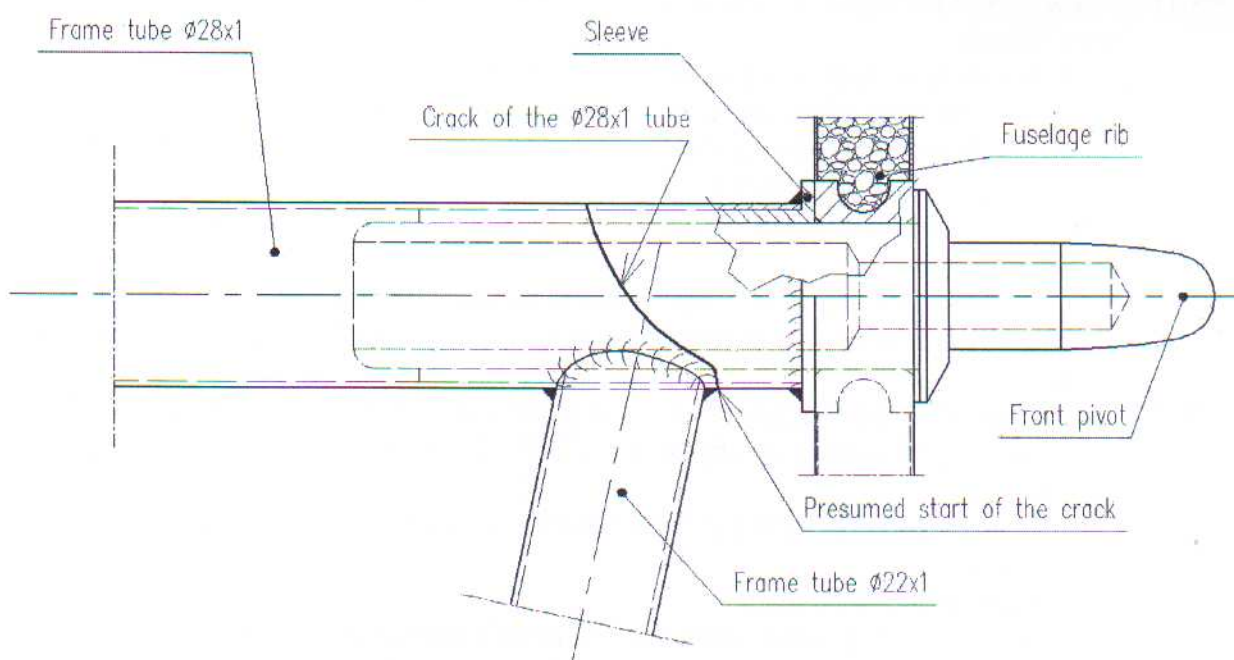
**Fig.1.**

During the exploitation of gliders a fatigue crack of the left front welded joint of the fuselage frame had been detected. The crack is a result of presumed high stress level and intensive exploitation in aerobatics. Real stresses initiates the cracks which can, in extreme case, cover all the diameter of the outer tube (Fig.1.).

Front wing fixing point
