AAIB Bulletin S3/2017

SPECIAL

ACCIDENT

Aircraft Type and Registration:	HPH Glasflugel 304 eS, G-GSGS	
No & Type of Engines:	1 LZ Design D.O.O FES-HPH-M100 brushless electric motor	
Year of Manufacture:	2016 (Serial no: 059-MS)	
Location:	Parham Airfield, West Sussex	
Date & Time (UTC):	10 August 2017 at 1121 hrs	
Type of Flight:	Private	
Persons on Board:	Crew - 1	Passengers - None
Injuries:	Crew - None	Passengers - N/A
Nature of Damage:	Fire damage to FES batteries and FES battery compartment	
Commander's Licence:	British Gliding Association Gliding Certificate	
Commander's Age:	55 years	
Commander's Flying Experience:	314 hours (of which 25 were on type) Last 90 days - 9 hours Last 28 days - 7 hours	
Information Source:	AAIB Field Investigation

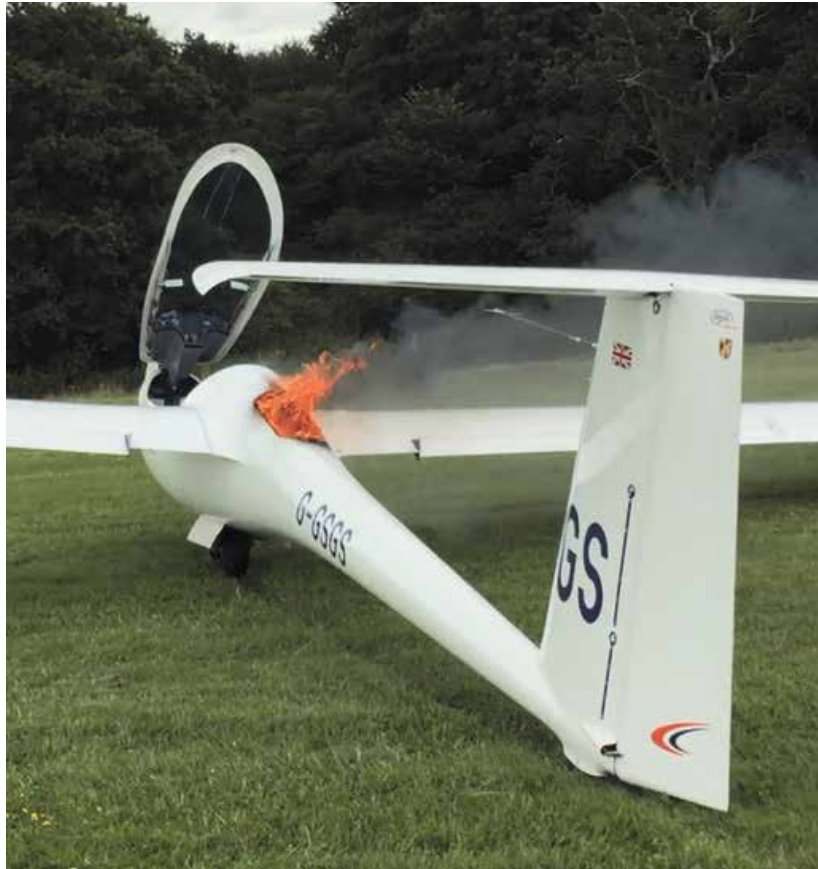
Figure 1

As the glider slowed during the ground run, the pilot smelled burning and the cockpit filled with smoke that was moving forwards from behind the pilot's head. The pilot did not report observing any warning messages or illuminated LEDs on the FCU, although his attention was drawn outside the cockpit during landing. He vacated the cockpit normally, without injury, and observed that the FES battery compartment cover was missing and that smoke, followed shortly by flames, was coming from the battery compartment. The airfield fire truck arrived promptly and an initial attempt was made to extinguish the fire using a CO₂ gaseous extinguisher, but this proved unsuccessful. Aqueous film-forming foam (AFFF) was then sprayed into the FES battery compartment and the fire was extinguished.

Fire in the FES battery compartment following the landing roll

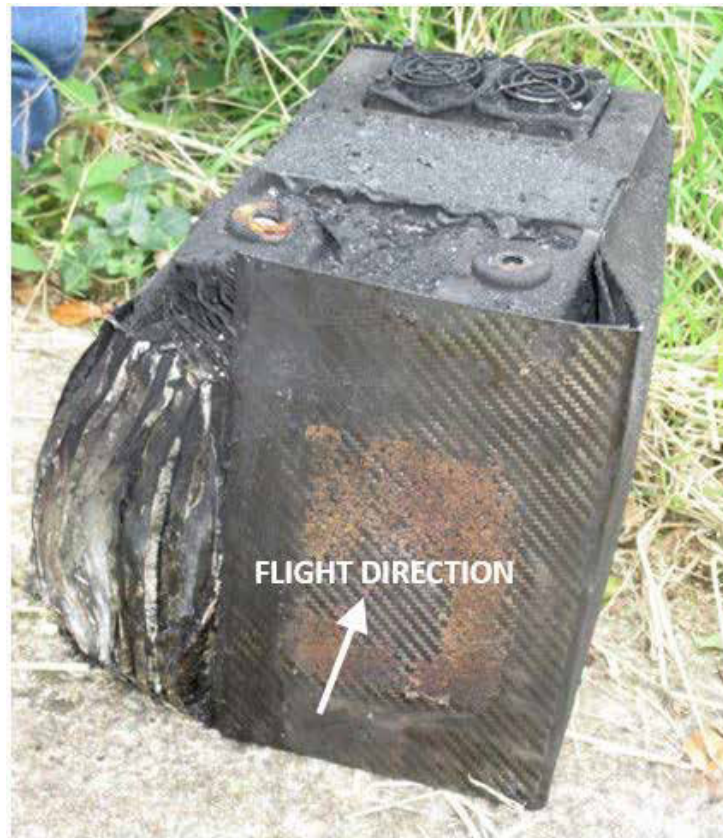
Figure 4

The origin of the fire was the forward FES battery; its battery box was ruptured along the rear left corner and the battery assembly was heavily fire damaged, Figure 4. The rear FES battery box suffered from external fire damage although the internal components were only slightly damaged and the cells remained charged.

Fire damage to the forward FES battery

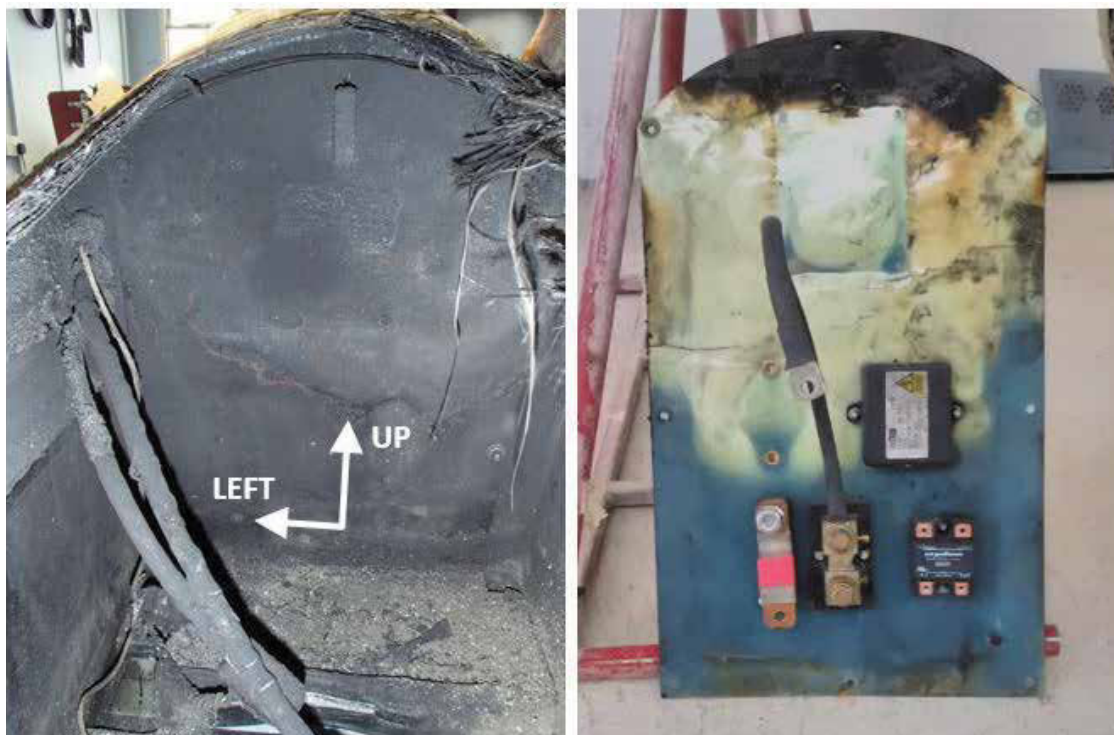
Figure 5

The FES battery compartment was heavily fire damaged with burning of the composite material's resin on the internal faces of the battery compartment and around the external cut-out in the upper fuselage skin. The top edge of the removable access panel that forms the front panel of the battery compartment (Figure 5) was also burned on its forward face and the FES electrical components in the equipment bay between the cockpit and the FES battery compartment were covered in soot deposits, demonstrating that the battery compartment had not contained all of the smoke and fumes released by the FES battery fire.

Fire damage to the FES battery compartment front access panel (left image, looking forwards), and to the forward face of the front access panel (right image, looking aft)
